# Pagedale, Missouri Rock Road Walkabout Follow Up Brief 2013

## Summary:

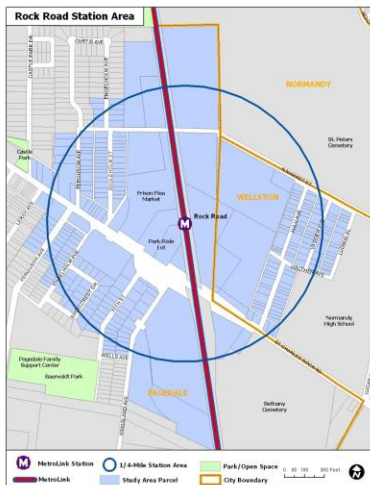
Diagram by permission from Metro St. Louis

Walkers met on the northern end of the station, close to the platform, and farthest from St. Charles Rock Road. The two hour walking tour started in the parking lot of the MetroLink Station. From the entry of the parking lot the group went south from St. Charles Rock Road and into the neighborhood down historic Kingsland Avenue, one of the first streets in the area. The group walked past vacant and occupied industrial sites as well as residential areas off Page Avenue. At Page the group continued west and at Ferguson Avenue, turned north to return to St. Charles Rock Road, then back to the station.

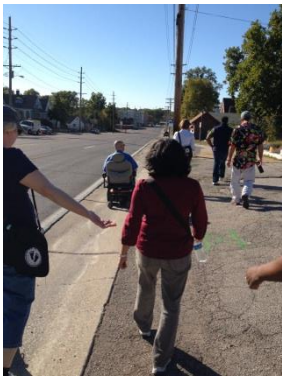
- Kingsland has unsafe speed
- Poor wayfinding
- Lack of sufficient bus shelters
- Page has no strongly defined edge between street and stores and parking.

- Significant slope that is not pedestrian friendly.
- Gutter is debris filled
- No trees
- Undefined pedestrian crosswalk, crossings at Ferguson and Page

- Poor sidewalk conditions including:
  - Sidewalks are not continuous. Completely missing in some areas.
  - Poorly defined sidewalk edges, sidewalks lack curb line.

Priority	Improvement	Possible Organization
Priority 1	Sidewalk Improvements	
	<ul style="list-style-type: none"> <li>▪ Improve widths</li> <li>▪ Pave 'cowpaths'</li> <li>▪ Add more sidewalks to provide better, more direct access to amenities.</li> <li>▪ Debris removal</li> </ul>	<ul style="list-style-type: none"> <li>▪ City of Pagedale</li> <li>▪ Metro</li> <li>▪ MoDOT</li> <li>▪ Beyond Housing</li> </ul>
Priority 2	Pedestrian Comfort	
	<ul style="list-style-type: none"> <li>▪ More shelters</li> <li>▪ Trees</li> </ul>	<ul style="list-style-type: none"> <li>▪ City of Pagedale</li> <li>▪ Metro</li> </ul>
Priority 3	Develop the Area Around Transit	
	<ul style="list-style-type: none"> <li>▪ Plan and develop multi-use area around transit station. Could provide a solid economic spark.</li> </ul>	<ul style="list-style-type: none"> <li>▪ City of Pagedale</li> <li>▪ Beyond Housing</li> <li>▪ Outside Developers</li> <li>▪ Grants</li> </ul>
